Testing of a Stitched Composite Large-Scale Multi-Bay Pressure Box

Dawn Jegley,¹ Marshall Rouse,² Adam Przekop,¹ Andrew Lovejoy¹
NASA Langley Research Center, Hampton, VA 23681

NASA has created the Environmentally Responsible Aviation (ERA) Project to develop technologies to reduce aviation's impact on the environment. A critical aspect of this pursuit is the development of a lighter, more robust airframe to enable the introduction of unconventional aircraft configurations. NASA and The Boeing Company have worked together to develop a structural concept that is lightweight and an advancement beyond state-of-the-art composite structures. The Pultruded Rod Stitched Efficient Unitized Structure (PRSEUS) is an integrally stiffened panel design where elements are stitched together. The PRSEUS concept is designed to maintain residual load carrying capabilities under a variety of damage scenarios. A series of building block tests were evaluated to explore the fundamental assumptions related to the capability and advantages of PRSEUS panels. The final step in the building block series is an 80%-scale pressure box representing a portion of the center section of a Hybrid Wing Body (HWB) tr

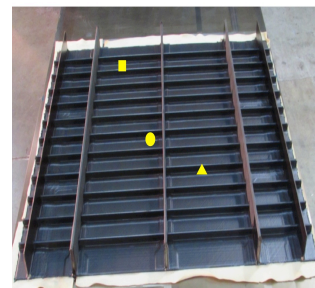
After the completion of the pristine structure tests, BVID was inflicted to the forward upper bulkhead and center keel panels. Three impacts to the interior of the structure, on the stiffened side of the upper bulkhead, and three impacts to the exterior of the structure, on the unstiffened side of center keel, were inflicted. Damage to the interior was inflicted using a spring-loaded impactor. Interior impacts were intended to represent a range of locations and the type of damage possible due to service events such as tool drops. Damage to the exterior was inflicted using a gravity-fed apparatus. Exterior impacts were inflicted to an area of the structure that would buckle during loading to evaluate whether typical exterior impacts caused by runway stones, service vehicles, etc., would degrade the post-buckling performance of the structure. In each case, a weight with a one-inch-diameter hemispherical tup was used for the impact. A detailed description of the impact method and results is presented in Ref. 31.

Figure 14. Impact sites on the center keel.

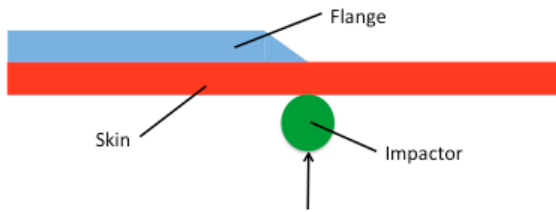
BVID for the interior sites corresponds to 20 ft-lb for the top of the stiffeners, which causes little damage, but is the maximum energy required for internal impacts for commercial aircraft, and 15 ft-lb for the skin mid-bay location, which yields visible damage that is evident. Damage was inflicted at locations at the top of a stringer, at the top of a frame, and at a mid-bay location between stiffeners, as indicated in Fig. 13. BVID for the exterior sites corresponds to energy levels of 60 ft-lb, 50 ft-lb, and 15 ft-lb for the frame flange, the stringer flange and the mid-bay locations, respectively. Damage was inflicted at these locations as indicated in Fig. 14. In Fig. 13 and Fig. 14, the impact sites are indicated by a circle, square, and triangle on the photograph, representing the frame, mid-bay, and stringer impact locations, respectively. A sketch of the location for the exterior impacts relative to the stiffener flange is shown in Fig. 15.

One of the exterior impacts was inflicted slightly away from the planned impact site. This impact was to the thin-skin region instead of at the adjacent flange. Therefore, the damage was more severe than intended. The damage was clearly visible from the exterior and interior and, in fact, a through-hole was created. Evaluation of the damage at this location relative to the anticipated loading and stress state indicated that this damage would not reduce the ability of the structure to sustain mechanical load, but could reduce the ability of the structure to support internal pressure loads. Therefore, a non-structural patch was taped over the hole on the stiffened side of the center keel. Ultrasonic scans were conducted immediately before and immediately after the impacts, so that the extent of damage caused by the impacts could be quantified. These scans indicated that delamination occurred at the keel skin and flange impact sites, but was arrested at the closest stitch line to the impact site. Scans of the bulkhead stiffener impacts found no damage. Scans of the skin interior impact showed delamination from the impact site to the closest stitch line to the impact site, which was at the adjacent flange edges. Ultrasonic results are discussed in Ref. 32 and 33.

Figure 15. Exterior impact site near the flange.

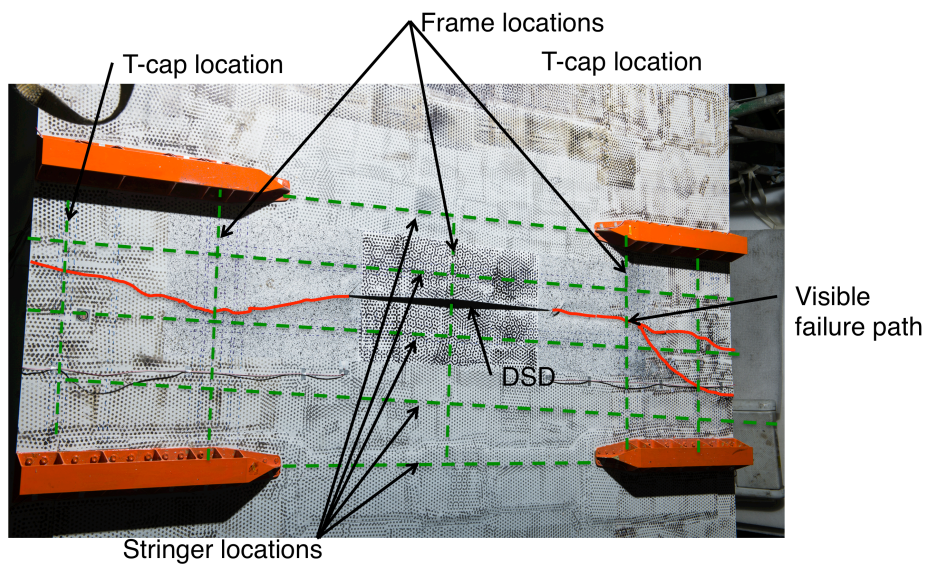
At approximately 242 kips, failure progressed through the forward and aft frames, through the forward and aft T-caps, and down into the forward and aft bulkheads. Additionally, when the center section of the crown panel could no longer support load, failures occurred in the crown and bulkheads near the inner ribs.

Therefore, it was determined that damage initiated at a load of approximately 130 kips and a series of damage progression steps occurred prior to the final failure at a load of 242 kips. It appears that damage arrested briefly at stitch lines, causing load redistribution during this process; however, this belief has not been proven conclusively at this time. Non-destructive inspection (NDI) results presented in Ref. 32 and 33 demonstrate that in the final failure sequence, damage stopped at the stitch lines in the bulkhead and crown panels. Photographs of the damage after failure of the test article are shown in Fig. 41 to Fig. 43.

Figure 41. Exterior view of the DSD region.

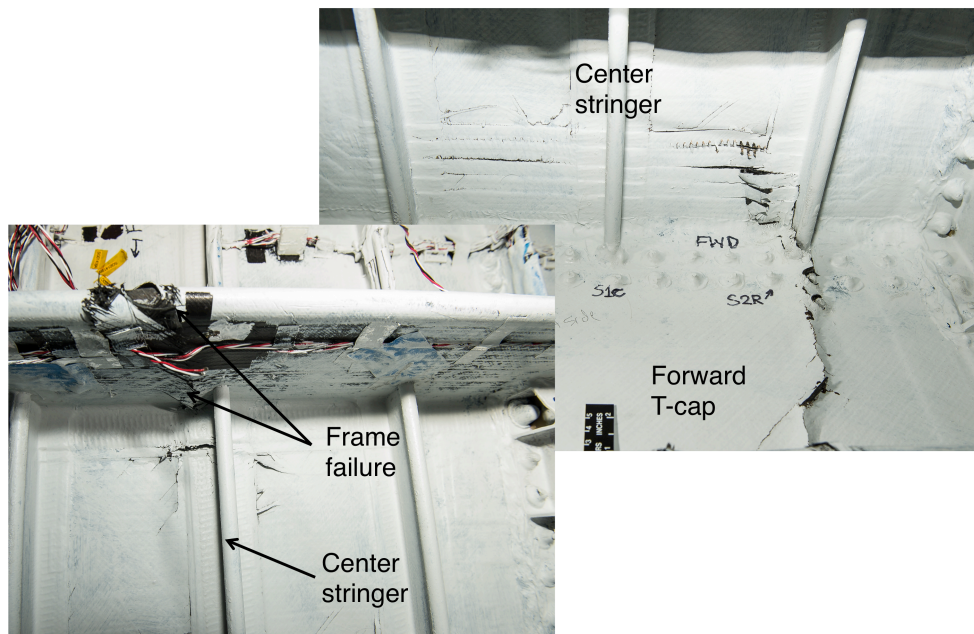
Figure 42. Interior view of failed frame in the DSD region.

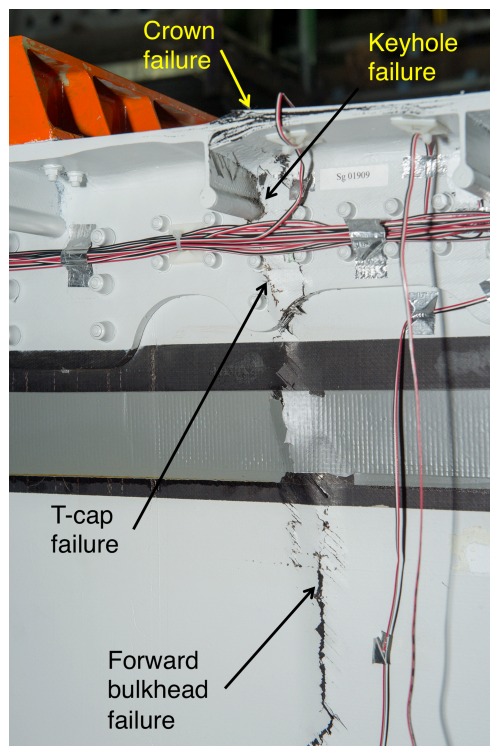
Figure 43. Failed bulkhead.
